Urgent Medical Device Recall

30/40/50 CC IAB Volume Connectors
MANUFACTURER: Arrow International

APPENDIX B

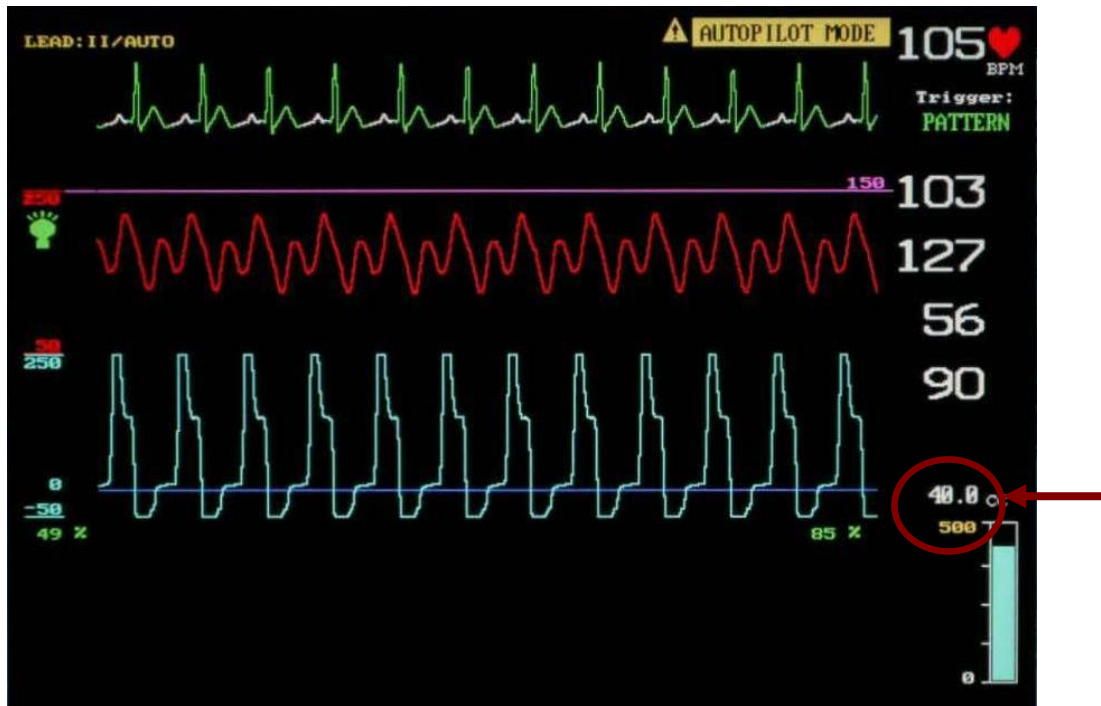
1. As stated in the Operators Manual (See pages: 5-4 to 5-11 and 6-4 for ACAT1; 5-3 to 5-11 and 6-13 for AutoCAT 2 rev.2.21 and 5-3 to 5-11 and 6-13 for AutoCAT 2 rev 2.23.) this issue can be recognized immediately by verifying the VOLUME SETTING displayed on the screen of the ACAT 1 Plus and AutoCAT 2 Series IABP Console. The currently set volume of the IAB balloon pump catheter is shown in the Lower Right Area of the display, below the Hemodynamic values and above the HE tank bar graph. As soon as the IAB connector is securely connected, the volume of the corresponding IAB catheter and connector should be properly displayed in the area shown. The IAB volume is also printed on the recorder strip.

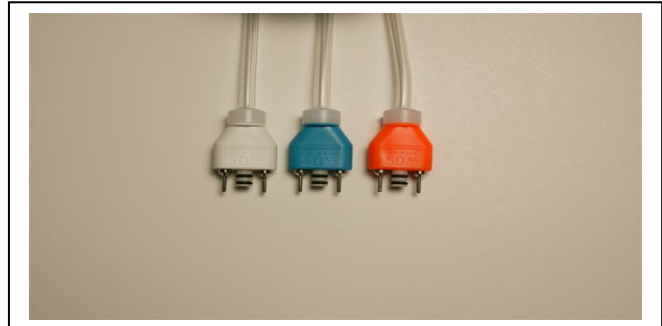
3. **Verify** that after the IAB connector of the IAB pump tubing assembly is attached to the IABP console, the volume setting is correct for the corresponding connector that is listed below. The volume settings are as follows for the each color coded connector below:

- a. **White Connectors: 30cc**
- b. **Blue Connectors: 40 cc**
- c. **Orange Connectors: 50 cc**

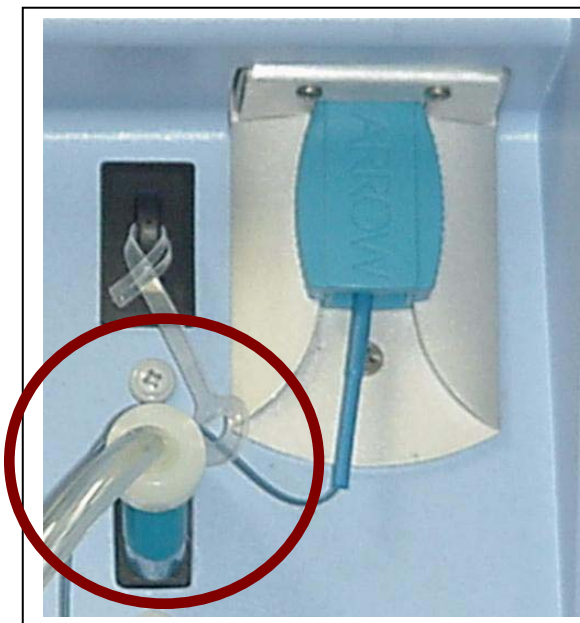
5. If the volume is NOT properly displayed and reads 2.5cc on the AutoCAT 2 Series or 5.0cc on the ACAT 1 Series;
- a. **Disconnect and Reconnect the IAB Pump Tubing Assembly connector** making sure the IAB pump tubing assembly connector is fully seated in the receptacle.

- b. **Verify the IAB volume setting on the IABP.** If it is showing the correct volume, no further action is required.
6. If the IAB volume is still **INCORRECT**, you should replace the IAB Pump Tubing assembly with a tubing assembly of the same volume size.
 - a. **DISCONNECT** the IAB pump tubing assembly at the QUICK CONNECT on the balloon.
 - b. **REPLACE** with another appropriate size pump tubing assembly. Pump Tubing Assembly may be ordered from Arrow using 30cc (Part Number IAK-02696), 40cc (Part Number IAK-02695), and 50cc (Part Number IAK-02693).
 - c. **RECONNECT** to IABP and verify IAB volume setting is correct, as described above.
